CGMS-35 EUM-WP-05
v1A, 17 October 2007

REPORT ON ANOMALIES FROM SOLAR EVENTS
In response to CGMS action PA 03

Report on Anomalies from Solar events

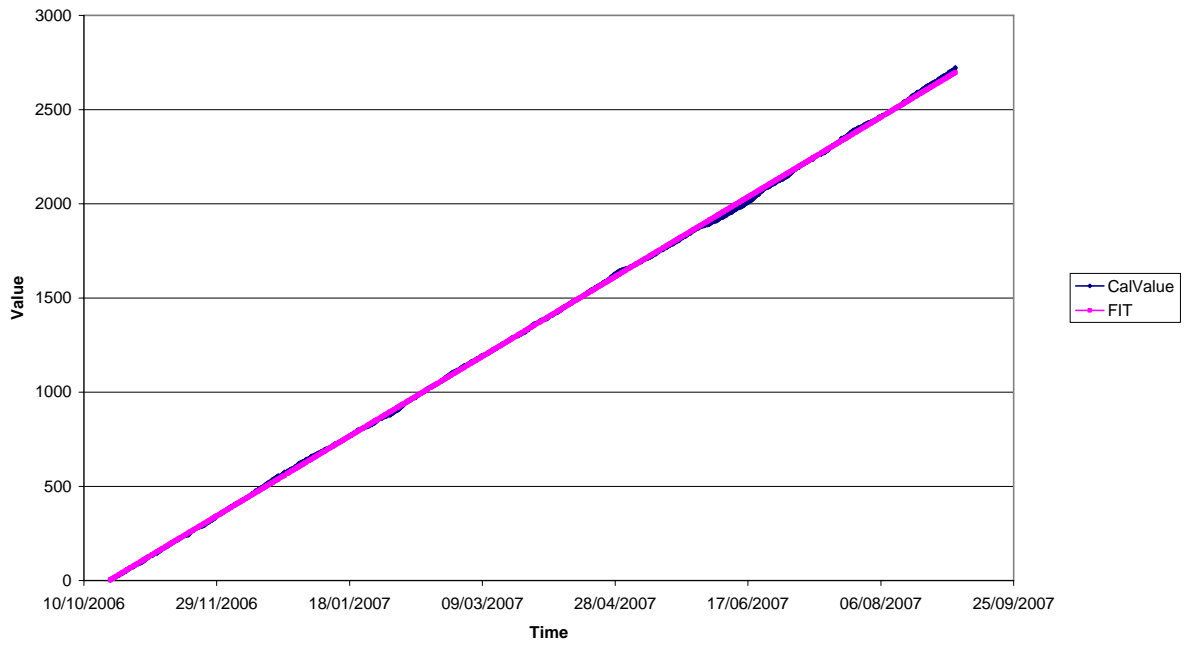
Cumulative Upsets

The following charts gives the cumulative number of SEUs over time, the hourly frequency of the SEUs, the geo-located probability of SEUs and the rate of correction of the EDAC of the Solid State Recorder on board, respectively. No outages have been caused by these detected SEUs (all corrected by the EDAC).
