CGMS-35 EUM-WP-05
v1A, 17 October 2007

REPORT ON ANOMALIES FROM SOLAR EVENTS
In response to CGMS action PA 03

Report on Anomalies from Solar events

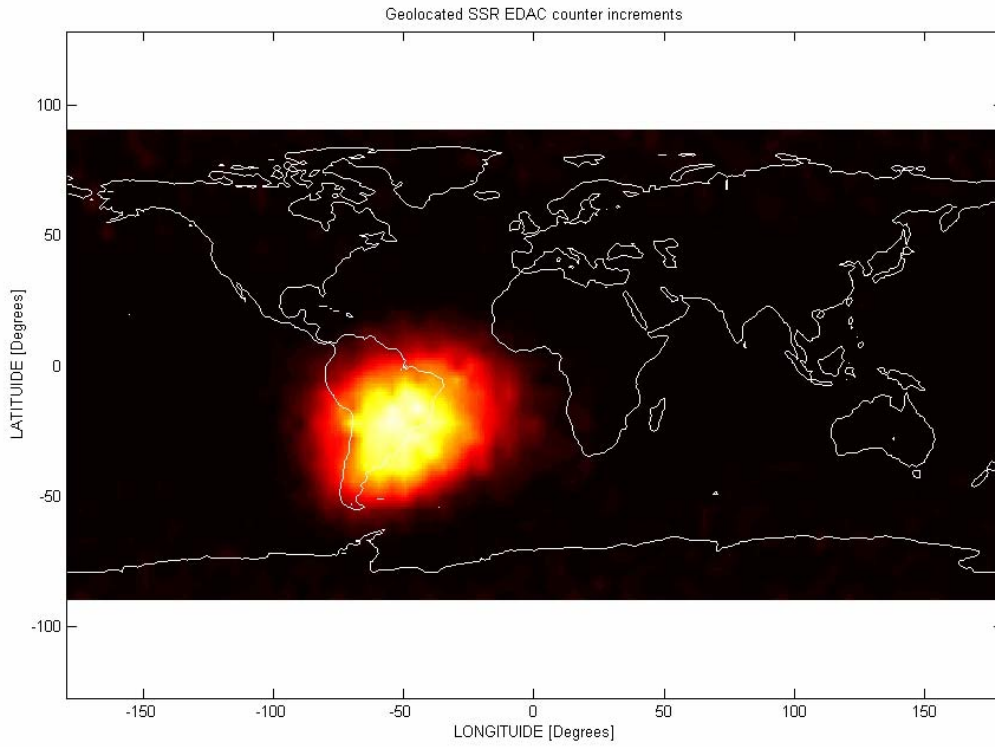
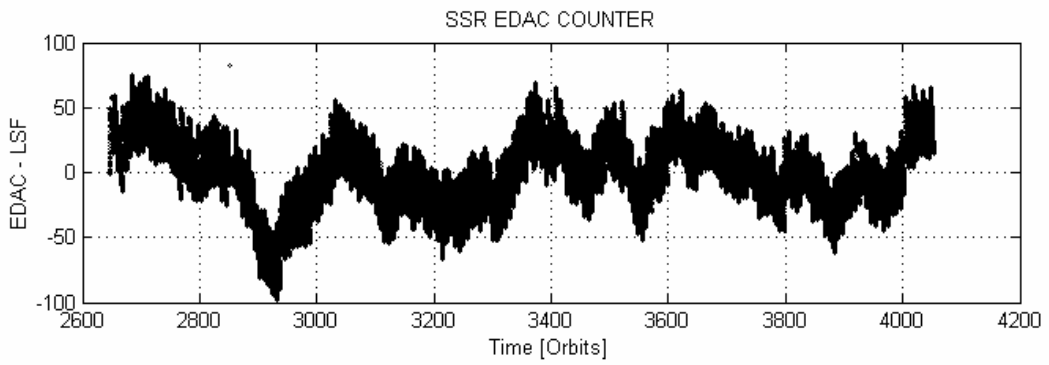
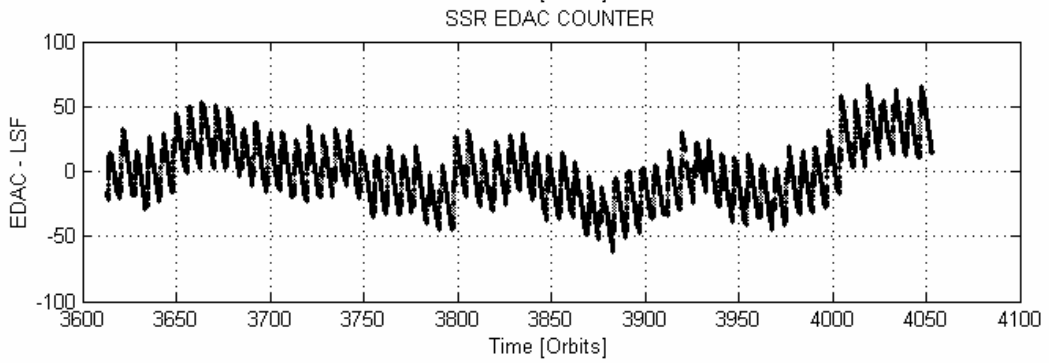
The following charts gives the cumulative number of SEUs over time, the hourly frequency of the SEUs, the geo-located probability of SEUs and the rate of correction of the EDAC of the Solid State Recorder on board, respectively. No outages have been caused by these detected SEUs (all corrected by the EDAC).
